### **Innavik Hydroelectric Project**

#### ***Annual Report – 2022***

#### ***Water Quality Monitoring***

May 19, 2023

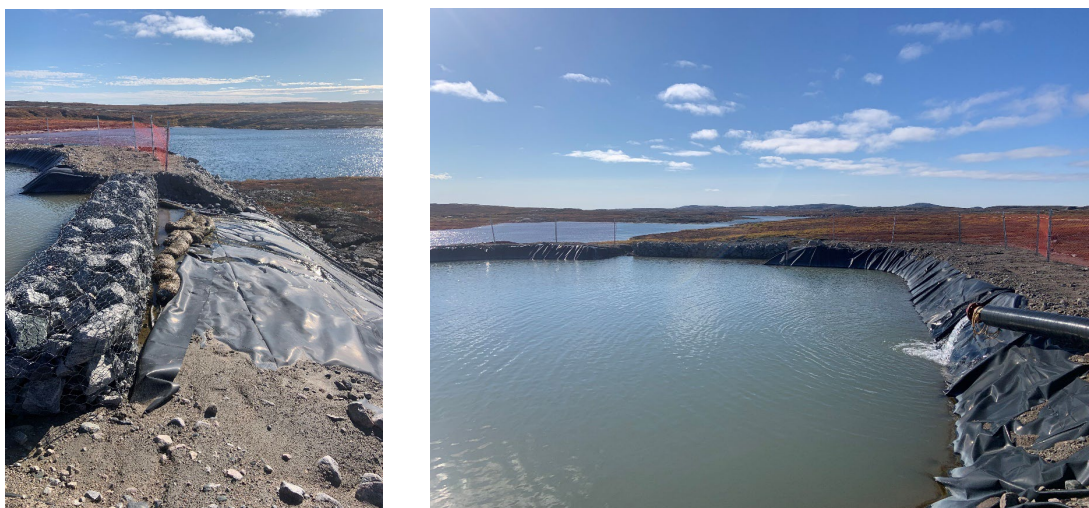
**Figure 1**      **Sedimentation pond – right bank**

The quality of the water generated during excavation work was monitored between June 24 and September 16, 2022. Water from this work (infiltration and rain) was channelled toward the sedimentation pond created in 2021 on the right bank of the Inukjuak River. After decanting, the water was channelled toward the vegetation before trickling onward toward the river (Figure 1).

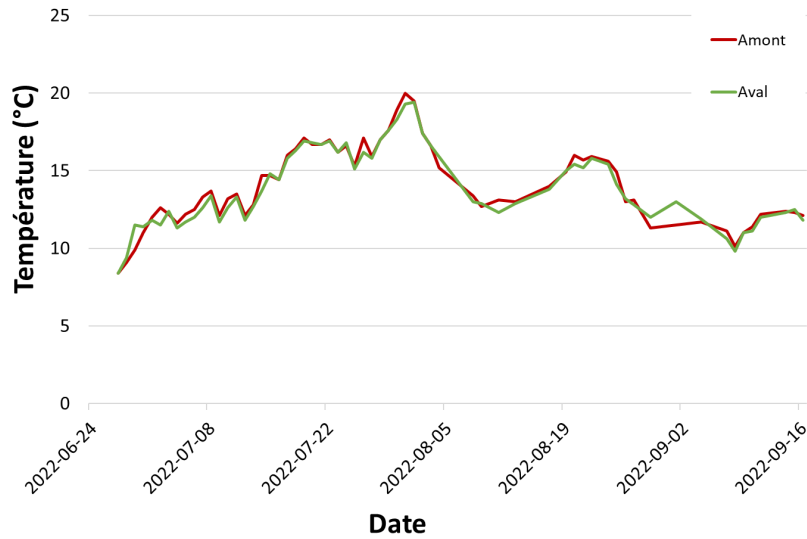
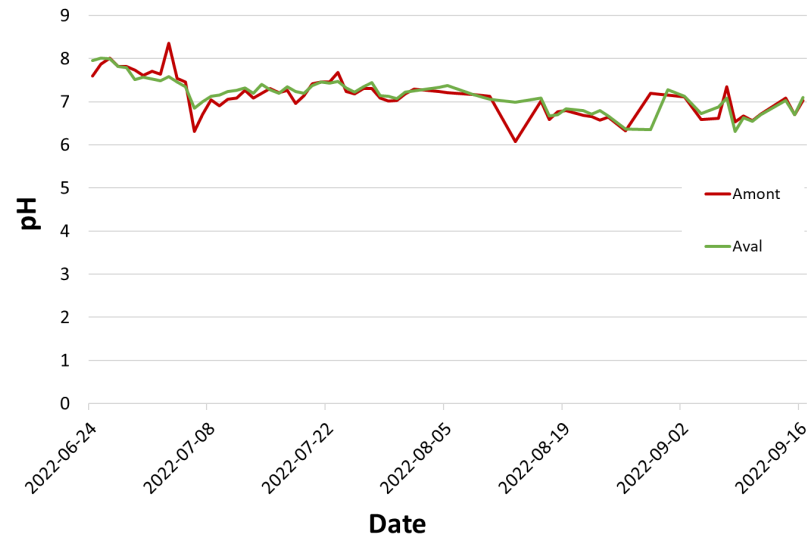
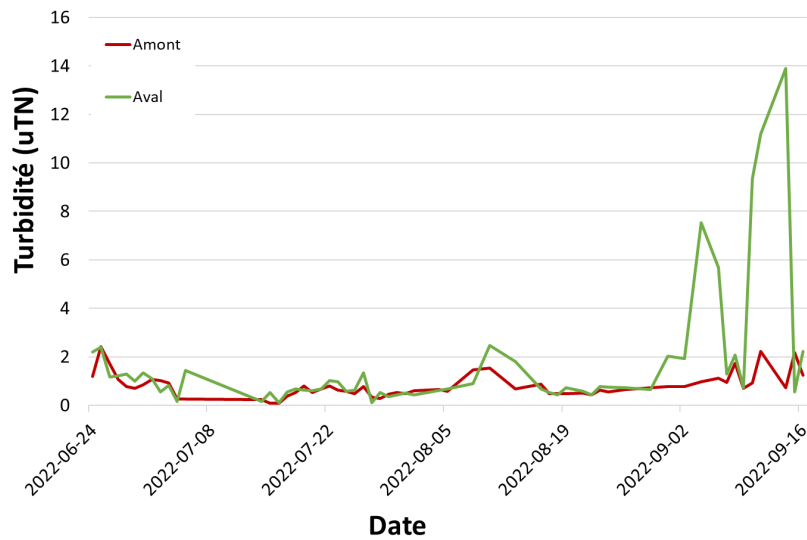
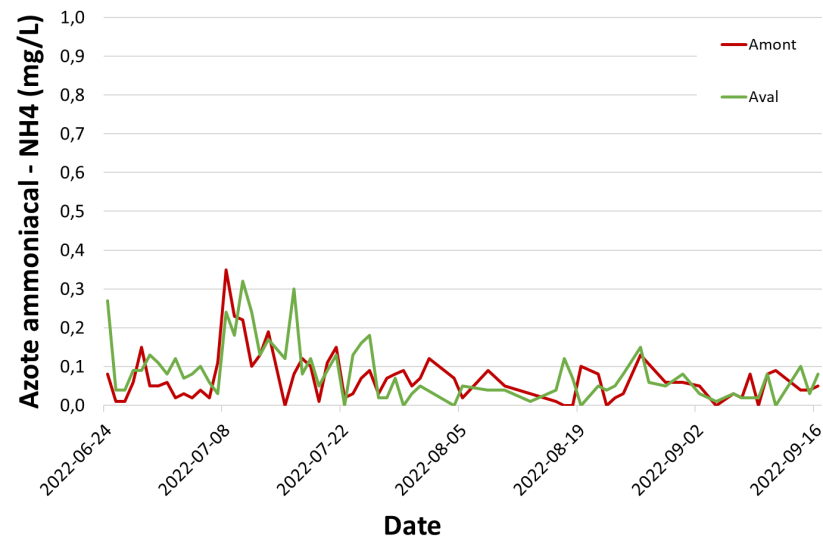
Figure 2 Monitoring results for water generated by excavation work in 2022

- pH levels below the sedimentation pond remained between 6.31 and 8.01 while upstream figures varied between 6.07 and 8.35. The pH was similar at the upstream reference site (mean = 7.13) and below the sedimentation pond (mean = 7.16);

- Water turbidity below the sedimentation pond varied between 0 and 13.9 NTU, whereas upstream values remained below 2.4 NTU. The highest values were obtained in September during excavation work to remove stone from a jetty built below the tailrace (Figure 2). Considering these measures, CRT Construction and Innavik Hydro immediately implemented the emergency response procedure (see details in Section 3). Prior to excavation of the jetty, turbidity below the construction site remained below 7.54 NTU;

- Water temperatures below the sedimentation pond varied between 8.4°C and 19.4°C and between 8.4°C and 20.0°C upstream;
- The concentration of ammonia-nitrogen (NH<sub>4</sub>) at the outlet of the sedimentation pond remained below 0.3 mg/L, whereas concentrations upstream of the construction site (at the reference site) remained below 0.4 mg/L. These values are below the surface water quality criteria for the protection of aquatic life, both for acute and chronic effects.<sup>1</sup>

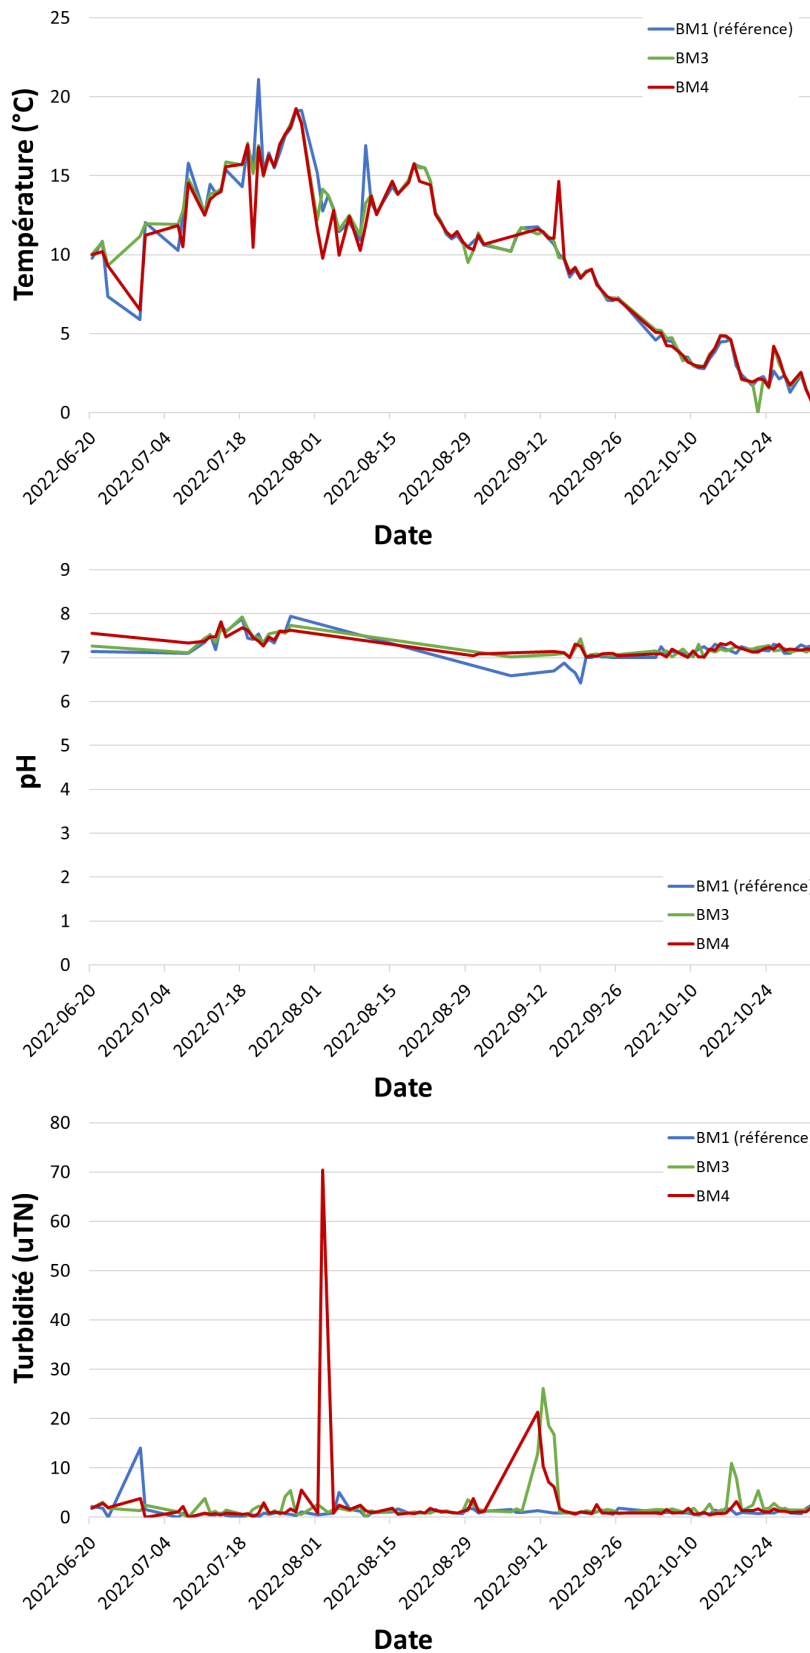
**Figure 4** Results of water quality monitoring in Inukjuak River upstream and downstream of construction site in 2022

- The pH of the water in the Inukjuak River was between 6.42 and 7.94. Generally speaking, pH values were similar upstream (BM1 mean = 7.19) and downstream (BM3 mean = 7.25; BM4 mean = 7.25) of the construction site;

- Turbidity varied between 0 FNU and 70.4 FNU. The higher values were obtained at BM3 and BM4 from September 11 to 14 during excavation of the jetty stone. During this period, peak turbidity was 26.1 FNU (September 12 – BM3). Turbidity returned to a level similar to that of BM1 beginning September 15, i.e. once work had been completed. Further, turbidity reached 11.0 FNU at BM3 on October 17, 2022 during excavation of the tailrace rock plug. This work lasted approximately one week. In both of these instances, CRT Construction and Innavik Hydro immediately implemented the emergency response procedure (see details in Section 3). Lastly, two abnormally high values were observed on June 29 at BM1 (14 FNU) and on August 2 at BM4 (70.4 FNU). These values do not coincide with any particular event; rather, they may be attributable to a faulty measurement device or human error. For turbidity, surface water quality criteria for the protection of aquatic life are linked to maximum increases over the baseline value,<sup>2</sup> as measured at BM1. The increase was more than 8 TNU during excavation of the jetty stone from September 11 to 14, thereby surpassing the criterion for the protection of aquatic life for acute effects. This increase was a one-off occurrence and turbidity quickly returned to normal levels;

- Temperatures varied between -0.1°C and 21.1°C;
- Concentrations of ammonia-nitrogen (NH<sub>4</sub>) were initially meant to be measured only during blasting periods, but the measurement device provided the reading by default. Measured concentrations varied between 0.03 and 7.40 mg/L upstream, between 0.02 and 10.90 mg/L at BM3 and between 0.02 and 2.90 mg/L at BM4. Three high values were observed at the reference site (BM1), namely on August 2 (4.00 mg/L), August 29 (7.40 mg/L) and September 26 (7.26 mg/L). These values do not correspond with any event in particular. A high value was observed on September 12 at BM3 (10.90 mg/L), which could be related to jetty excavation. These one-off values are below the surface water quality criteria for the protection of aquatic life for acute effects. Average values calculated at each site are below the thresholds for the aquatic life protection criterion for chronic effects.<sup>3</sup>

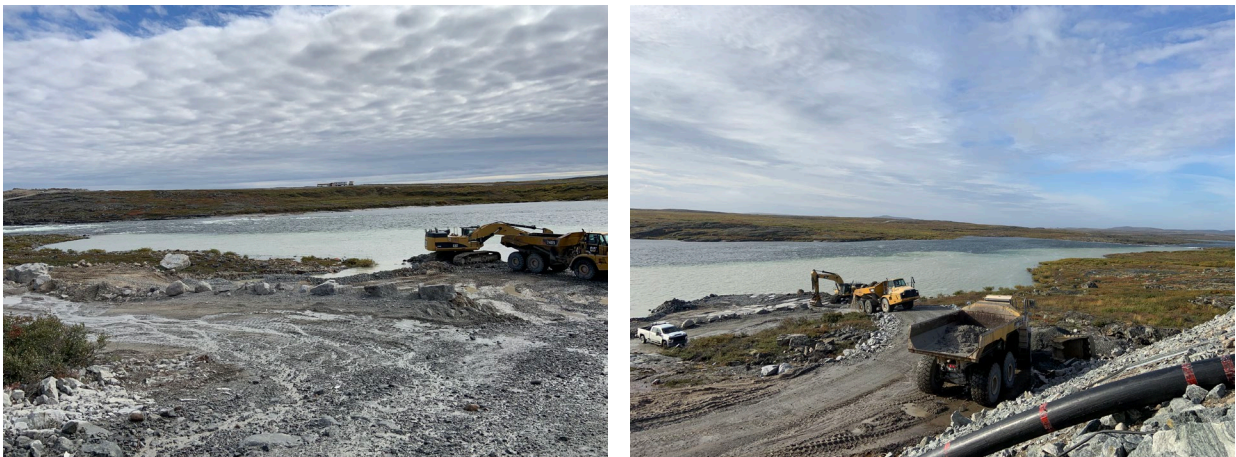
**Figure 7** *Formation of a plume following jetty excavation*

Installation of stone in the jetty below the tailrace began on July 26, 2022. Both the Northern Village and community members were informed of the commencement of work. In September, excavation of the jetty stone was carried out and an increase in turbidity was noted (Figure 7). The emergency response procedure was initiated due to sediment flow to the pumping station (BM4; Figure 3).

Rock plug excavation in the tailrace resulted in increased turbidity in the Inukjuak River (Figure 7). This work lasted one week. The emergency response plan was implemented from October 14 to 21, 2022 based on the water quality results. During this period, CRT Construction made a tanker truck available to the Northern Village to help deliver water to local residences. This tanker truck drew water at the temporary water intake upstream of the construction site, then parked at the camp on the outskirts of the village. From there, tanker trucks owned by the Northern Village came to fill up and subsequently distribute the water to local households.

Excavation of the jetty was completed on September 14, 2022 at approximately 15:30. The following morning, i.e. September 15, the town manager re-opened the valve at the pumping station based on the water quality results. For the entire duration of construction work, CRT Construction made a tanker truck available to the Northern Village to facilitate the delivery of water to local residences. This tanker truck drew water at the temporary water intake upstream of the construction site, then parked at the camp on the outskirts of the village. From there, tanker trucks owned by the Northern Village came to fill up and

subsequently distribute the water to local households. This measure was maintained until September 15 inclusively in order to completely fill the reservoirs of the Northern Village's treatment facility.
